# The Negev

The Challenge of a Desert

Michael Evenari

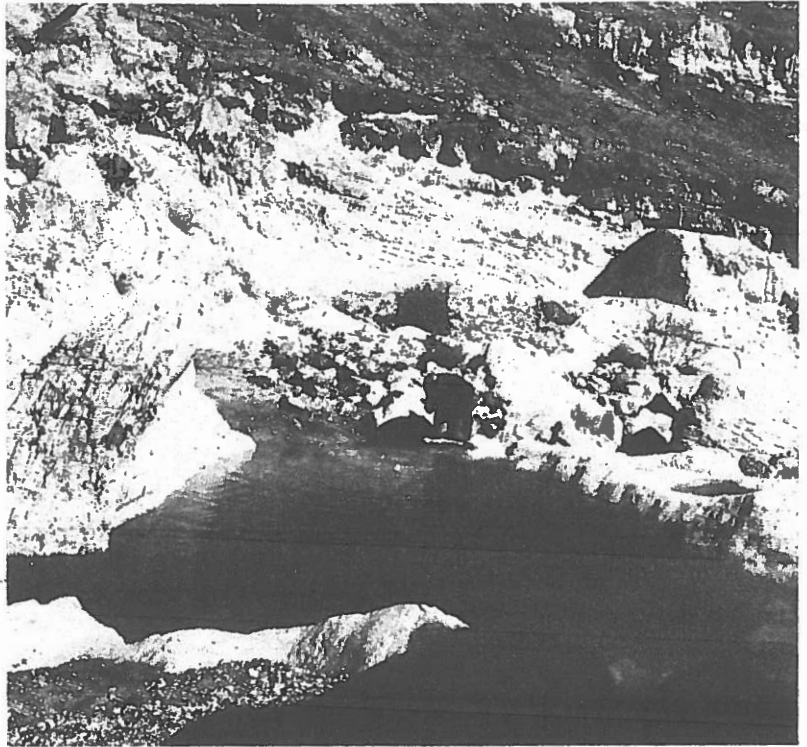
Fig. 96. Natural rock basin filled with flood water.

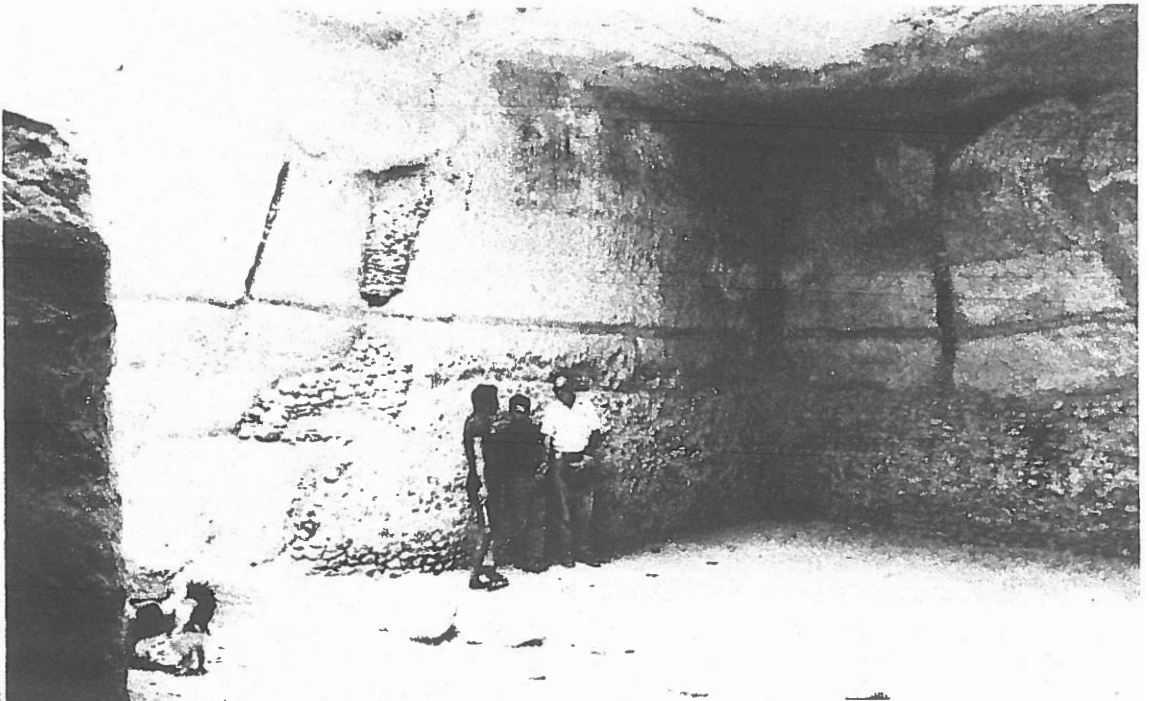
Fig. 97. Inside of a large rock-hewn cistern. All cracks have been filled with stones; the mortar plaster that once covered these stones is still partly visible.

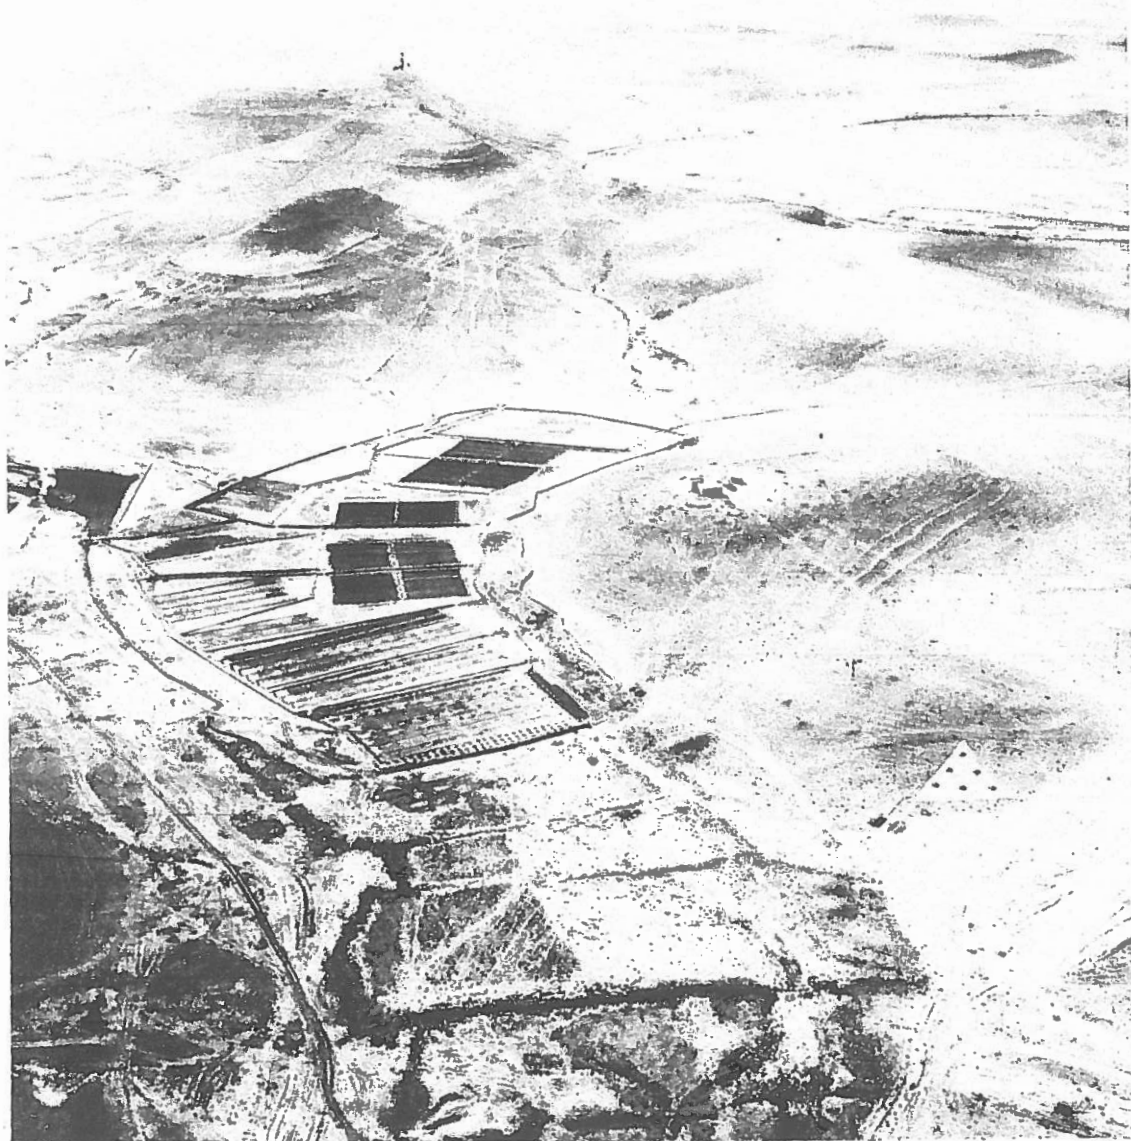
Fig. 111. Aerial photograph of the Avdat farm. In the foreground are four unreconstructed terraces of the ancient farm. The farmhouse is on the hill at the right. Blocks 1-14 can be easily identified (compare Fig. 113). In the background are six reconstructed channels leading runoff from the hills to the various weirs. On the hill to the right of the farmhouse the traces of three unreconstructed channels can be seen. In the background are remains of ancient farms.
